Evaluation of the current condition of Montrose House, Mpophomeni, KwaZulu-Natal Province-November 2007

**Umngeni Municipality
PO Box 5
Howick
3290
November 2007**

Evaluation of the current condition of Montrose House, Mpophomeni, KwaZulu-Natal Province

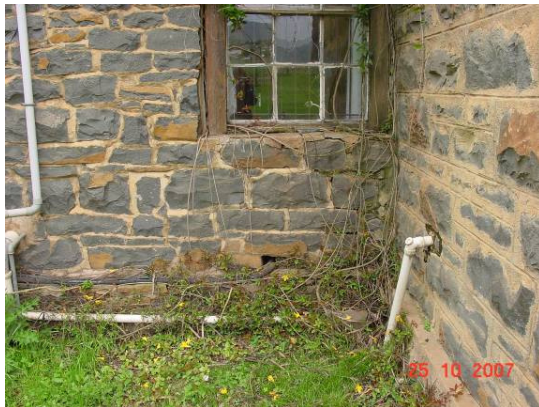
This invasive creeper is prevalent in the house, causing much damage particularly on the southern side, where it has climbed into the roof space. It has also entered the walls through the mortar joints penetrating the ladies bathroom. At plinth level, also on the southern elevation, it has begun to pop out of the stonework, again displacing the mortar and creating apertures for penetration of water. On the north elevation, the cats-claw creeper is vigorous at ground level, close to the walls and foundations.

Fig 1: the creeper at ground level

Thus, the most critical issue is eradicating, by some means, the cats-claw creepers, improving the efficacy of the water-drainage and replacing the rainwater goods.

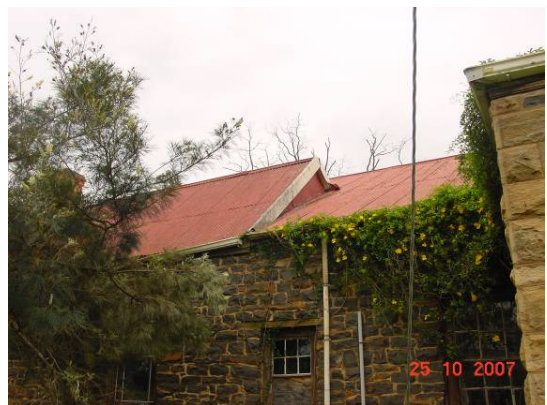
In the roof, cats-claw has penetrated the corrugated sheeting and assisted in the damage to the structure of the valley gutter above the ladies bathroom, also damaging guttering and fascias.

Fig 2: the creeper at roof level

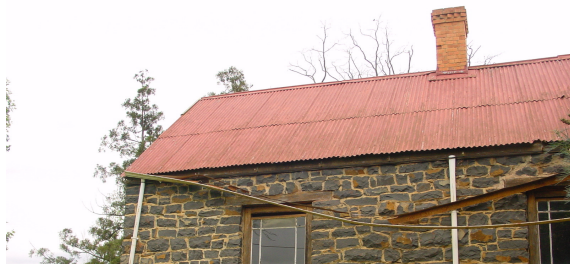
As with all buildings, both new and old, maintenance is a critical part of the longevity of the structure. In the last number of decades, some reactive work has been done, and some also some aesthetic work which was not necessarily appropriate. The complete disintegration of the rainwater goods on the south side of the building is a case in point. (see fig 3) Putting into place maintenance guidelines will also be a valuable part of this study. See *Chapter 6- operational recommendations and maintenance* in this regard.

Fig 3: disintegration of rain water gutters

Replace all gutters and down-pipes with a half-round galvanized iron gutter, painted.

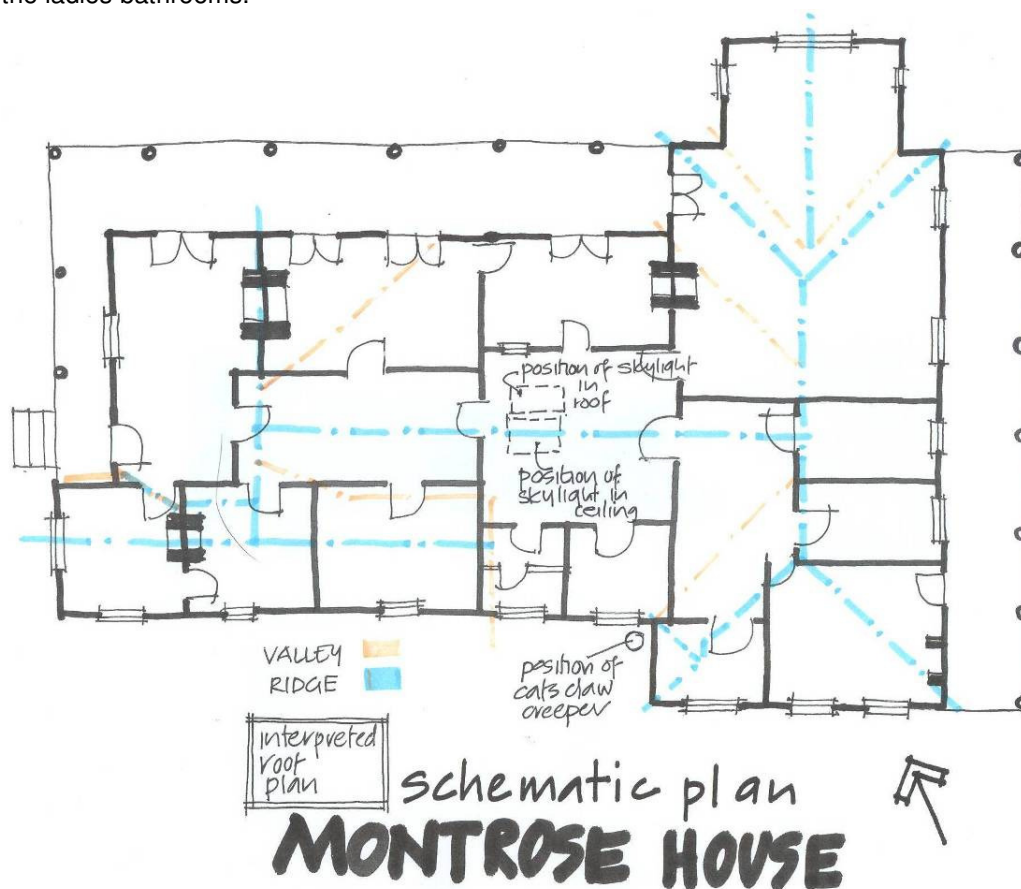
Fig 4: Roof plan

- The corrugated sheeting showed little evidence of internal rust. It is in good condition despite the lack of maintenance, but does have a few puncture holes in places which let in the rain.
- The most problematic issue is the penetration of the cats-claw creeper
- Also, there are major junctions that need remedial work, viz:
 - the connection between the above-mentioned original structure and the main roof
 - the flashing around the skylight
 - flashing around all chimneys
 - repair and replace all the valleys.

*Check all roofing nails replace those where necessary
 seal those where necessary*

Replace all flashing to the chimneys

Replace flashing to the skylight and seal

Repair ventilator and finial to the eastern elevation and repaint

Sand down skylight in the roofspace, replace the tongue-and-groove where necessary, and repaint.

Replace roof vent in the north elevation

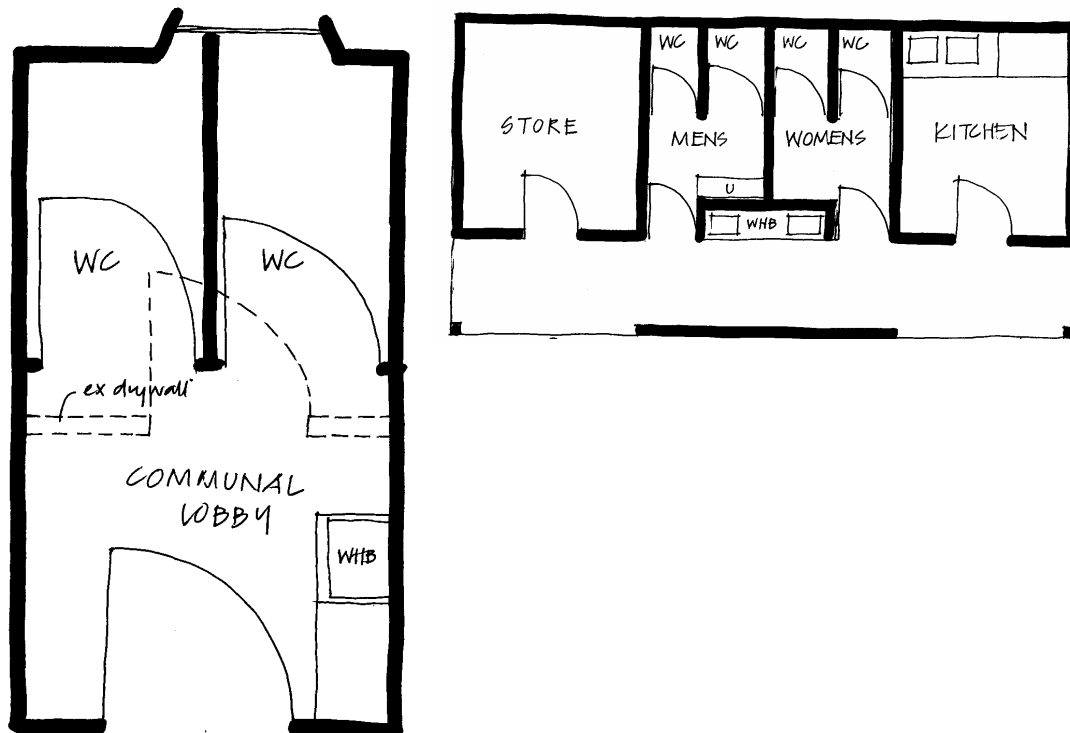
Fig 10: suggestion for reconfiguration of room 4 as a communal staff toilet

Fig 11: suggestion as to the provision of an outside wet core-storeroom

Given the lack appropriateness of including the bathroom spaces within the building, it is suggested that the wet core be totally removed from the house, and, together with a kitchen and a store room, can form part of an outside structure. This means that any major incident which involves water and heating totally avoids the house.

Should the need arise to include one bathroom inside Montrose House for staff, it is suggested that this be carried out in the most sympathetic and modest manner possible.
